# Manhole Inspection Summary

Manhole # S21K\_\_032MH

Insp Date: **4/3/08 11:40 AM**

**Location** Address: **1930 wilhelm-mchenry alley**

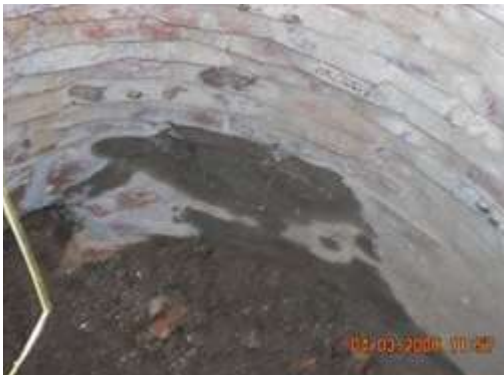
Defect 1

Infiltration: ☐ None ☐ Joint ☐ Cracks ☐ Mortar ☐ Roots ☒ **Wall**

infiltration @ barrel wall

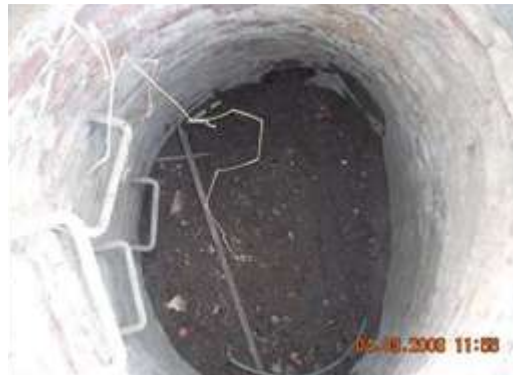
Defect 2

Condition: ☐ Sound ☐ Cracked ☐ Root Intrusion ☐ Deteriorated ☐ Leaks ☒ **Debris**

Channel Debris

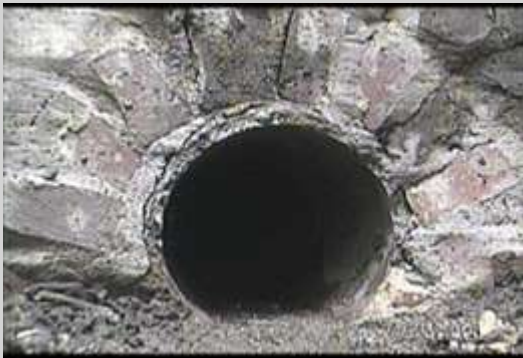
12 O'Clock Outflow

8 in. Circular Gravity Sewer  
Pipe Out @ 12 O'Clock

Deposits: ☐ None ☒ **Mud** ☐ Sludge ☐ Debris ☐ Grease

Silt Depth: **1** (in.) Deposits Extent: **Light**
